ERDC/CHL TR-04-11

Monitoring Completed Navigation Projects Program

Inspections of Previously Monitored Rubble-Mound Coastal Structures

Final report

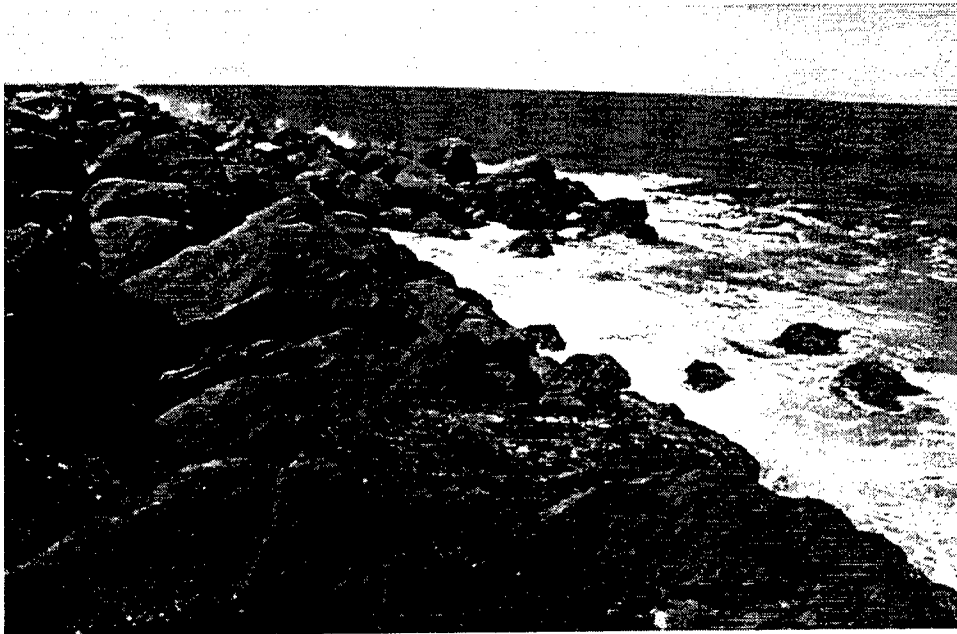
The troublesome history of the Yaquina Bay north jetty, coupled with some of the harshest wave conditions on the west coast of the United States, prompted the monitoring study. The jetty was monitored during the period October 1988 through September 1994 (Hughes et al. 1995). The objectives of the monitoring study were to (a) determine what mechanisms were responsible for damage that occurred at the Yaquina Bay north jetty, (b) use the study information to improve Corps design and construction capabilities for similar harsh environments, and (c) obtain information for use in the design of a permanent repair of the north jetty. At the conclusion of the monitoring, a notch, or void region, was clearly visible on the sea side of the jetty approximately 30.5 m (100 ft) shoreward of the tip. In addition, it was apparent that stones also were missing from the sea side of the jetty tip.

Figure 5. Head of Yaquina Bay north jetty on 24 June 1997

Subsequent to the 1997 inspection, the head of the north jetty was again rehabilitated. It was capped with 34,475-kg (38-ton) stone on a 1V:2.5H slope above the waterline. A two-layer (6.9-m-wide (22.5-ft-wide)) toe berm consisting of 26,310-kg (29-ton) stone was placed from the waterline to the ocean bottom to buttress the main body of the jetty head. The crest width of the head was increased from 9.1 to 12.2 m (30 to 40 ft). The repair section extended from sta 68+00 to 70+00. Construction was completed in September 2001.

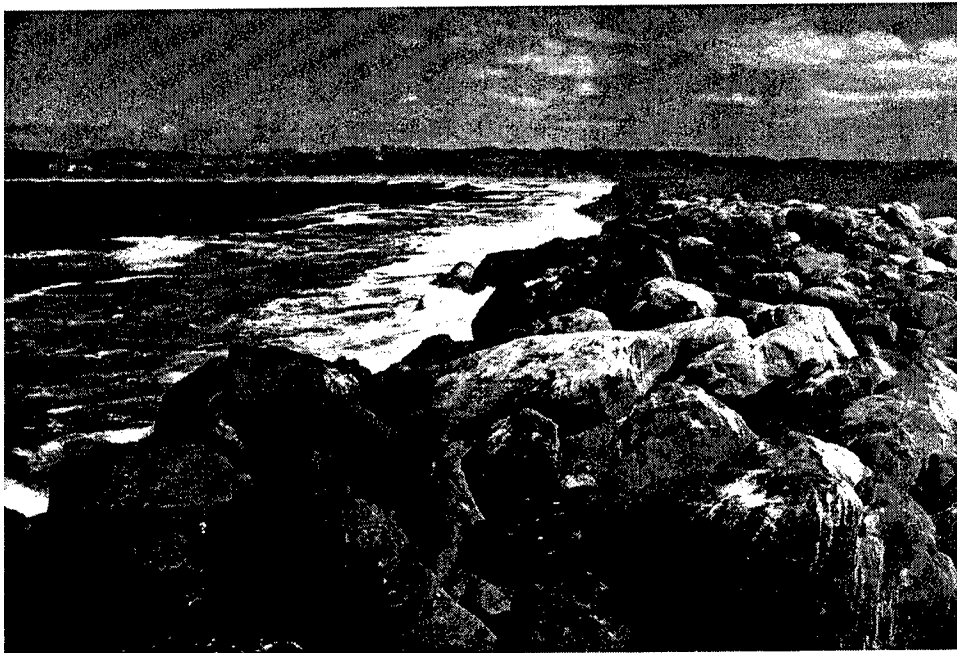
The most recent walking inspection of the Yaquina north jetty was conducted on 27 August 03. The head of the jetty was in excellent condition. The trunk of the structure was similar to that observed in 1997. Subsidence was observed in areas along the crest on the seaward portion of the jetty. Voids observed previously (Figures 6 and 7) appeared to be similar in appearance, and there were other sporadic areas along the crest that could use armor stone to bring the jetty back to its design cross section. Overall, the structure was in good condition.

Figure 6. Voids on seaward side of Yaquina north jetty

- b. Inspection of the Yaquina Bay north jetty, OR, revealed some low areas in the crest and some voids on the slopes of the jetty. These observations were also noted in the previous inspection of 1997. The head of the structure, rehabilitated in 2001, was in excellent condition. Consideration should be given to placing armor stones in the voids of the structure trunk during scheduled maintenance to prevent future major damage, and in areas along the structure crest to bring the jetty back to its design cross section. The trunk of the jetty is in good condition overall. The structure should be inspected periodically, particularly after major storm events.

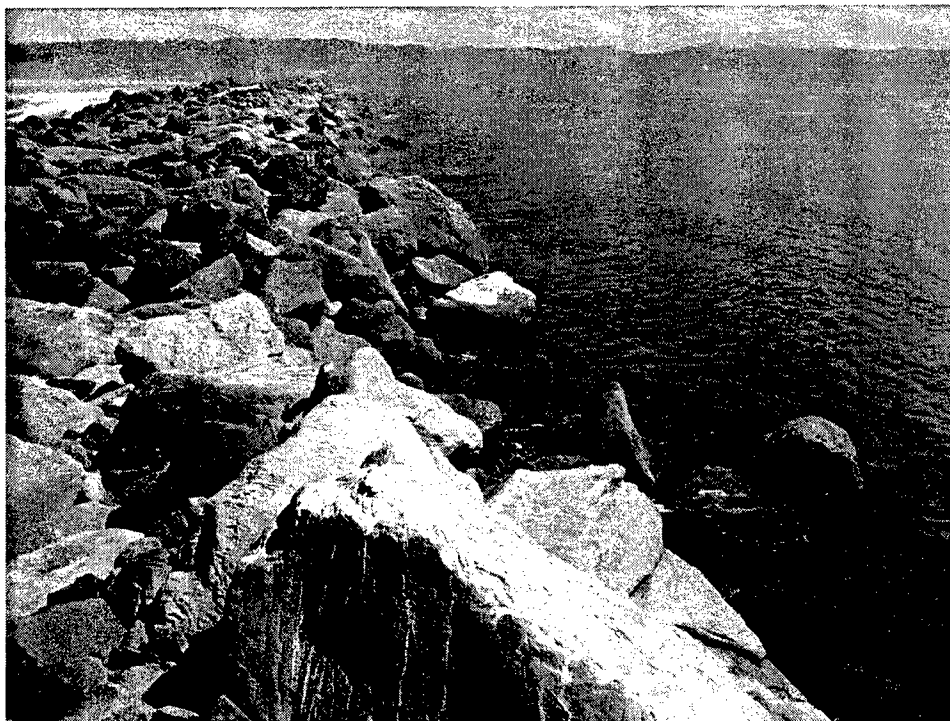
Figure 7. Void on channel side of Yaquina north jetty

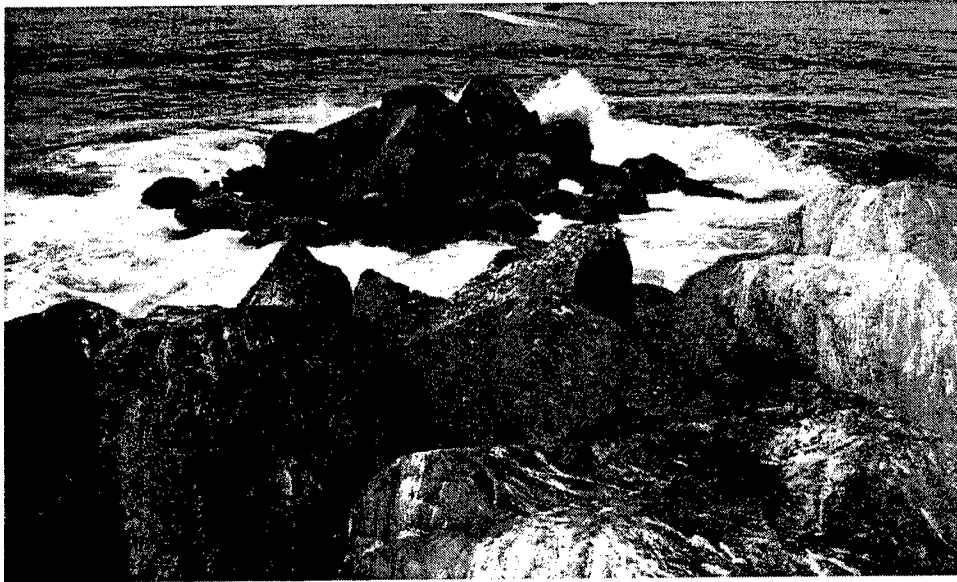
The most recent walking inspection of the Umpqua training jetty and south jetty was conducted on 26 August 2003. Observations revealed the conditions of the structures were generally similar to the previous inspection of 1997. A small void was noted, however, where the training jetty tied into the revetment on the landward end. Small voids in the crest as well as slight subsidence in a few areas were also observed along the crest of the training jetty. A view of the training jetty is shown in Figure 12. The breach at the head of the south jetty appeared also to have subsided slightly since it was below the water level (Figure 13). Slight subsidence was also noted in a couple of areas on the crest of the south jetty. The slopes of both structures were in good condition except for the void and breach areas.

Figure 13. Breach at head of Umpqua south jetty

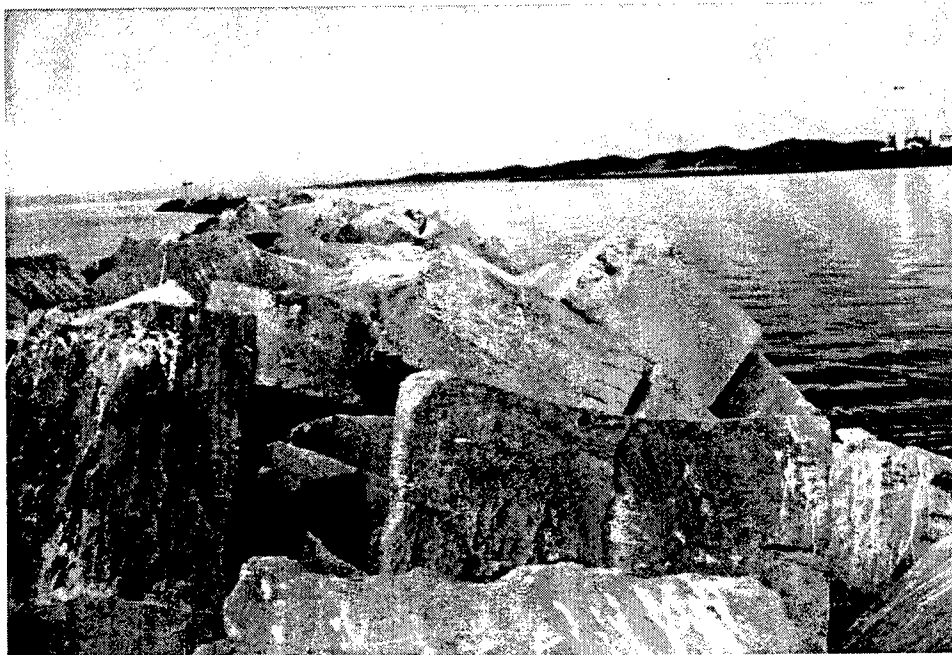
A walking inspection of the Burns Harbor north breakwater (Figure 20) was conducted on 17 June 1998. The elevation of the breakwater was compared to topography data obtained previously during the photogrammetric analysis. Numerous sections of the structure appeared to have lost el since the previous survey. The inspection also indicated several voids in the breakwater. It appeared that continued deterioration of the breakwater had occurred since the 1994/1995 inspection. It was noted during the inspection, however, that a barge was working lakeward of the north breakwater. Construction of a submerged, offshore reef breakwater was ongoing. The submerged reef was designed to reduce wave heights at the north breakwater during storms, thus resulting in less structure damage as well as decreased wave heights in the harbor. Construction of the reef breakwater was completed in the fall of 1998. Model studies were used to determine reef layout (Acuff and Bottin 1995) and ensure stability (Carver and Wright 1995).

Figure 20. View of Burns Harbor breakwater in 1999 (looking east)

Subsequent to the 1999 periodic inspection of the structure, numerous repairs were made to the north breakwater. Between 1999 and 2003, 174,263,923 kg (192,092 tons) of stone were placed on the structure. Repairs to the lakeside were conducted from sta 0+00 to 23+70 and sta 32+50 to 40+65; and repairs on the harbor side occurred from sta 10+50 to 46+30. Repairs involved the placement of stone to flatten the breakwater slopes and raise the crest to design levels. Additional stone placement is scheduled for 2004-2005.

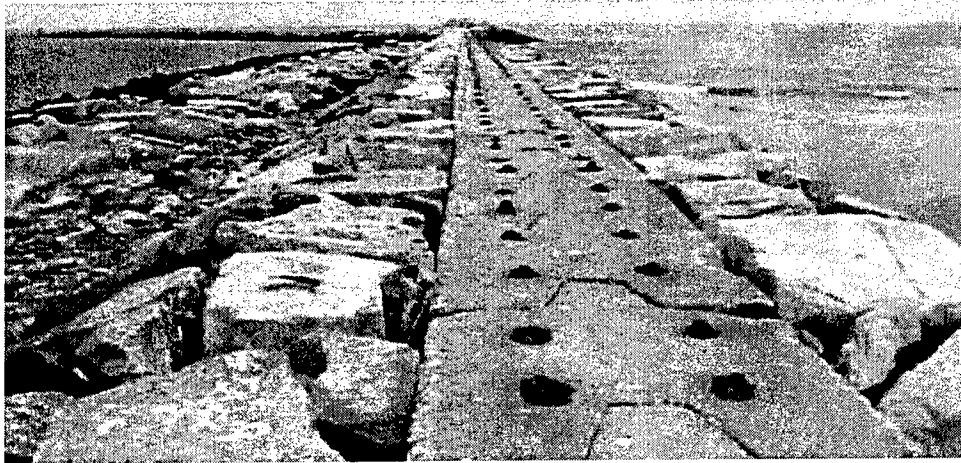
The most recent walking inspection of the Ocean City Inlet south jetty and headland breakwaters was conducted on 29 May 2003. Armor stone positions were compared to photographs obtained previously in 1997. The rehabilitated south jetty (to sta 13+00, Figure 34) and the three headland breakwaters (Figure 35) appeared to be in excellent condition. No voids were noted, no broken armor stones observed, and the cross sections again appeared to be as-built. It was noted that slight spalling of the precast concrete core was occurring (probably due to weathering), but the structure was structurally and functionally sound. The recently rehabilitated outer portion of the south jetty (beyond sta 13+00) also appeared to be in excellent condition (Figure 36).

Figure 34. View of inner portion (to sta 13+00) of rehabilitated Ocean City inlet south jetty trunk

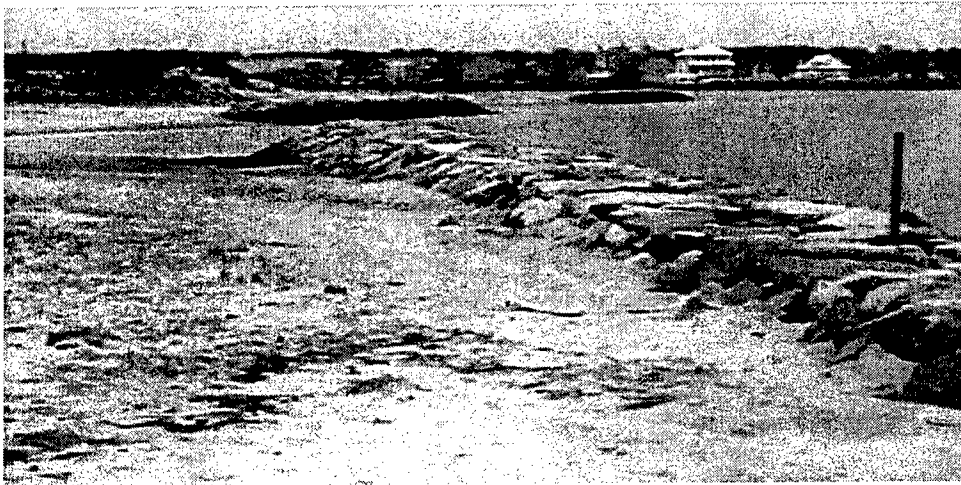
Figure 35. Headland breakwaters at Ocean City inlet constructed to stabilize shoreline
